Test Report

No. AJFS1910010753FF

Sample Description: LUCENT LIGHTING DOWNLIGHTS GROUP 2

Fire Resistance Test of the Loadbearing Timber Floor Assembly Sample, Incorporating Nine Fire Rated Downlights Fittings, in accordance with EN 1365-2-2014 Fire resistance tests for loadbearing elements Part 2: Floors and roofs.

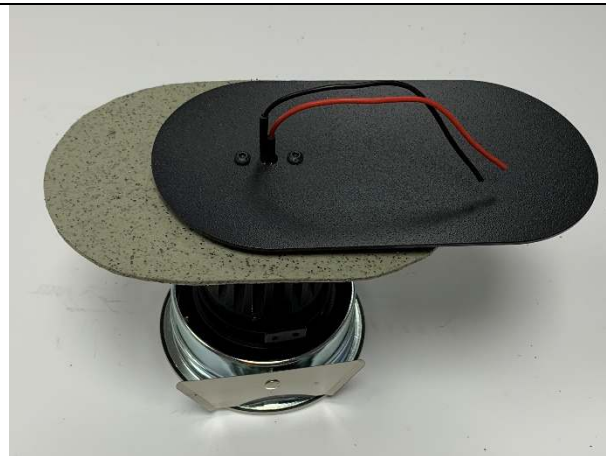
Photo 6: Side view of specimen C

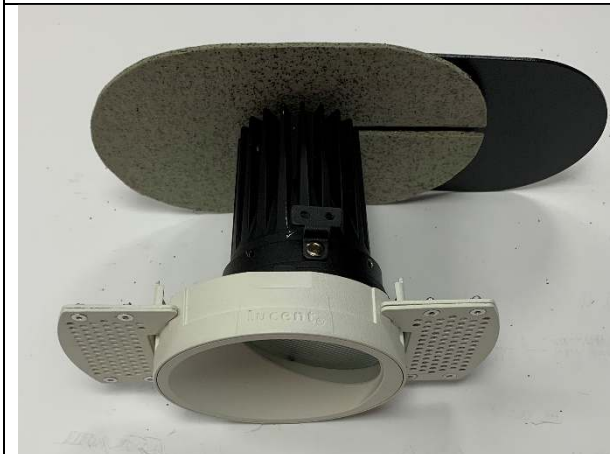
Photo 7: Front view of specimen D

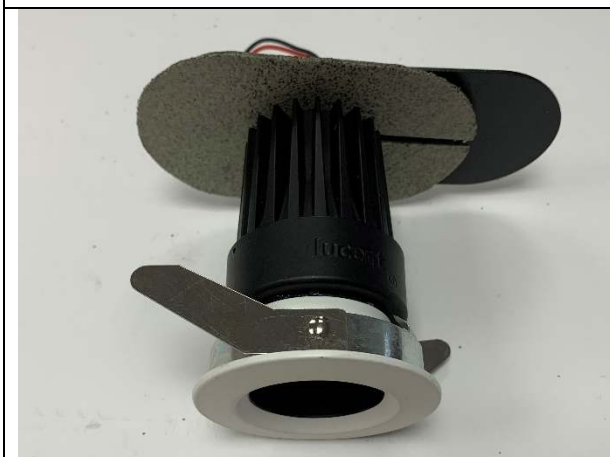
Photo 9: Front view of specimen E

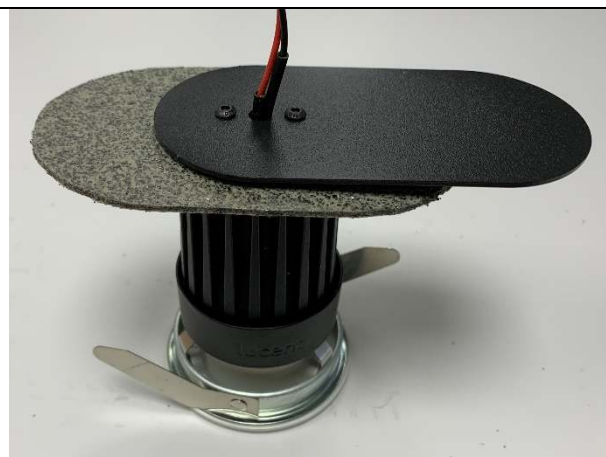
Photo 10: Side view of specimen E

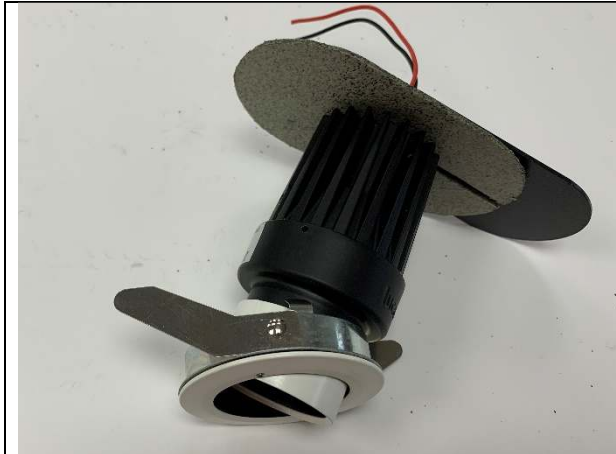
Photo 17: Front view of specimen I

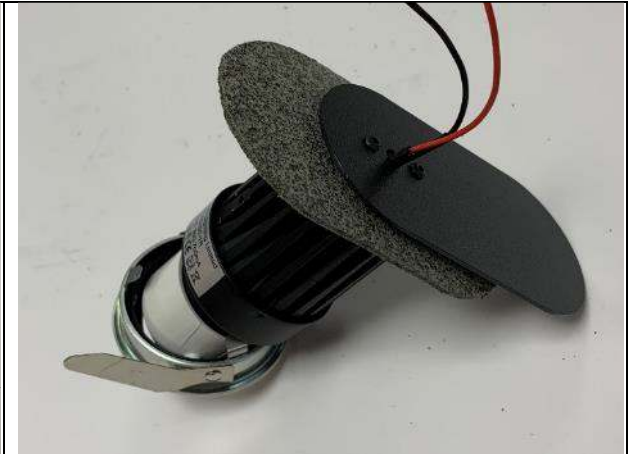
Photo 18: Side view of specimen I

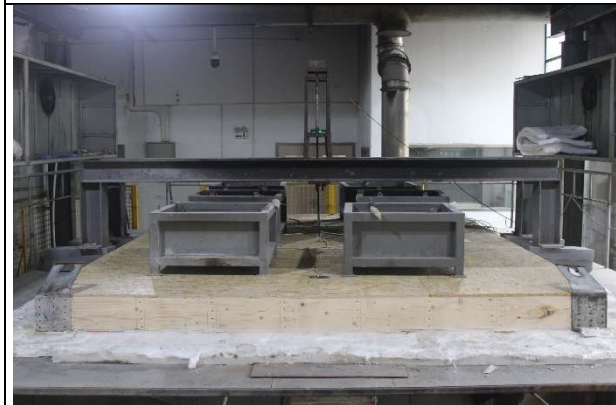
Photo 19: The unexposed face before the test

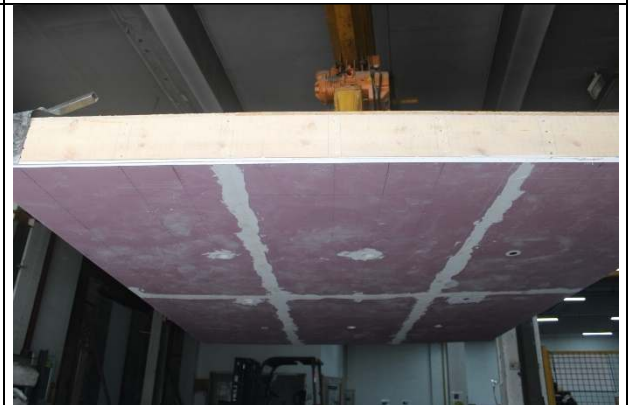
Photo 20: The exposed face before the test

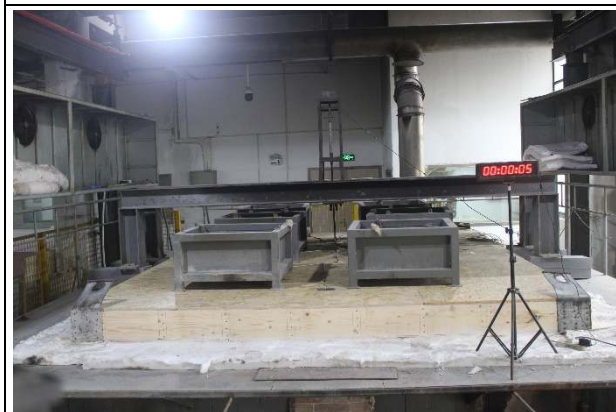
Photo 21: The unexposed face of sample
(Test start)

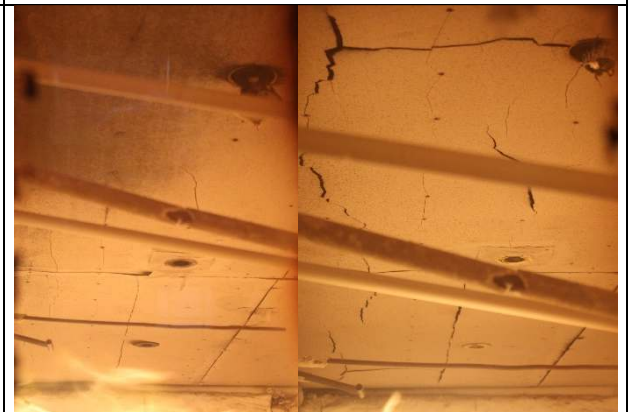
Photo 22: The exposed face of sample
(After test duration of 5 & 20 minutes)

Time (min:sec)	Observations
00:00	Furnace Fired
01:05	Slight smoke released from the joints between the joists and flooring
06:00	The downlights surface was carbonized and discolored.
13:10	The outer layer plasterboard of exposed surface cracked.
17:20	Some downlight components melted and dropped off.
21:30	The outer layer plasterboard cracked seriously.
33:10	The outer layer plasterboard began to fall off.
40:00	The plasterboards fallen increased.
44:30	The outer layer plasterboard on exposed face detached increased, and some flame was issued from the joints at the centre of flooring.
52:15	The second layer plasterboard began to fall off.
56:00	Big flame was issued from the joints at the centre of flooring internally.
60:00	The sample maintained the loadbearing capacity and kept integrity and insulation.
61:00	Test was terminated as per client requirement.

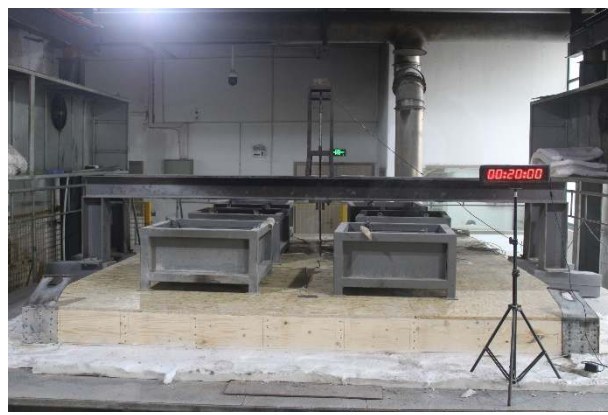
Photo 23: The unexposed face of sample
(After test duration of 20 minutes)

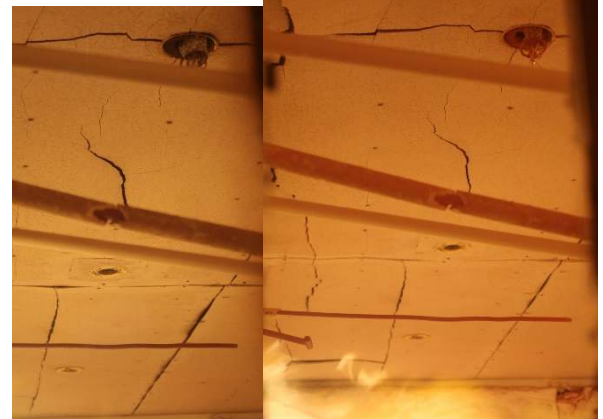
Photo 24: The exposed face of sample
(After test duration of 30 & 40 minutes)

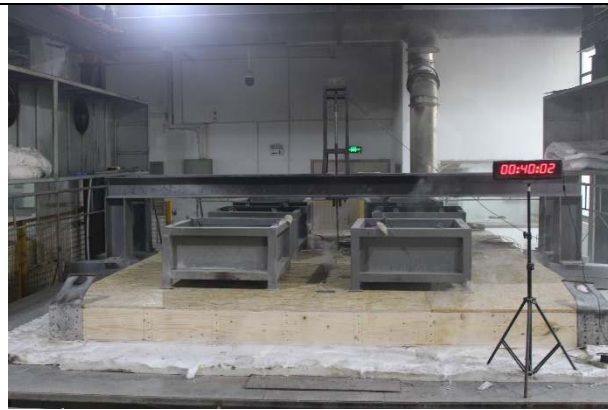
Photo 25: The unexposed face of sample
(After test duration of 40 minutes)

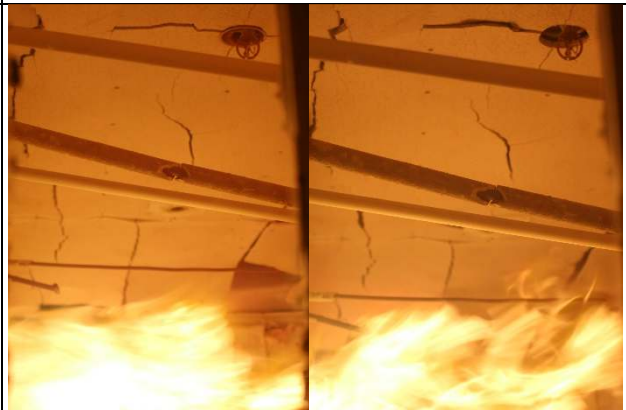
Photo 26: The exposed face of sample
(After test duration of 50 & 55 minutes)

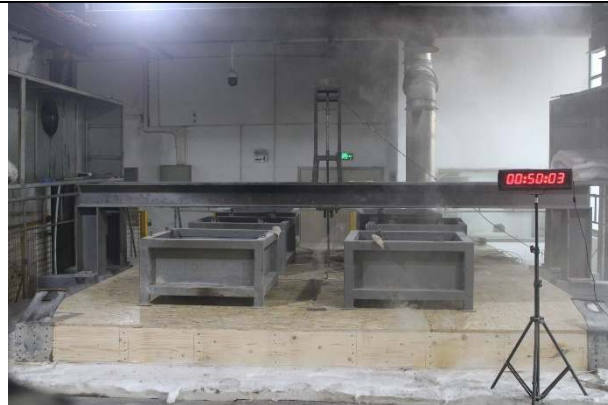
Photo 27: The unexposed face of sample
(After test duration of 50 minutes)

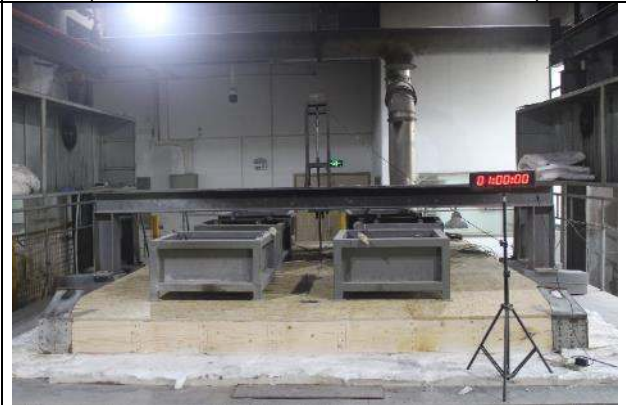
Photo 28: The unexposed face of sample
(After test)
